DEVELOPMENT OF A FIXED,
PERMANENT MOORING SYSTEM
ON THE PINNACLE OF
COBB SEAMOUNT

FINAL REPORT BY THE OCEANOGRAPHIC INSTITUTE OF WASHINGTON

25 April 1971

ROCK BOLT ANCHOR PULL TESTS August 24, 1970

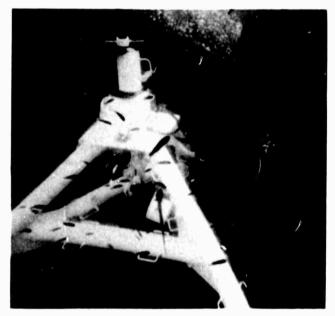
A diver from Ocean Systems, Inc. descends with the coring rig to the pinnacle. With a diamond bit, OSI drilled and extracted three basalt cores. Divers then pneumatically forced cement grout into the holes and inserted the 2½" x 5' steel bolts. Marked with arrows to indicate magnetic north, the cores are now under study by geologists.

A diver from Foundation Sciences, Inc. of Portland, Oregon, operates the hydraulic test rig during tests of one bolt assembly. At about 110 tons of vertical pull, failure occurred between the bolt and the grout. The yield strength was 50 tons and the safe load 35 tons. Although it withdrew about one and a half inches, the bolt still had some 20 tons of residual strength.

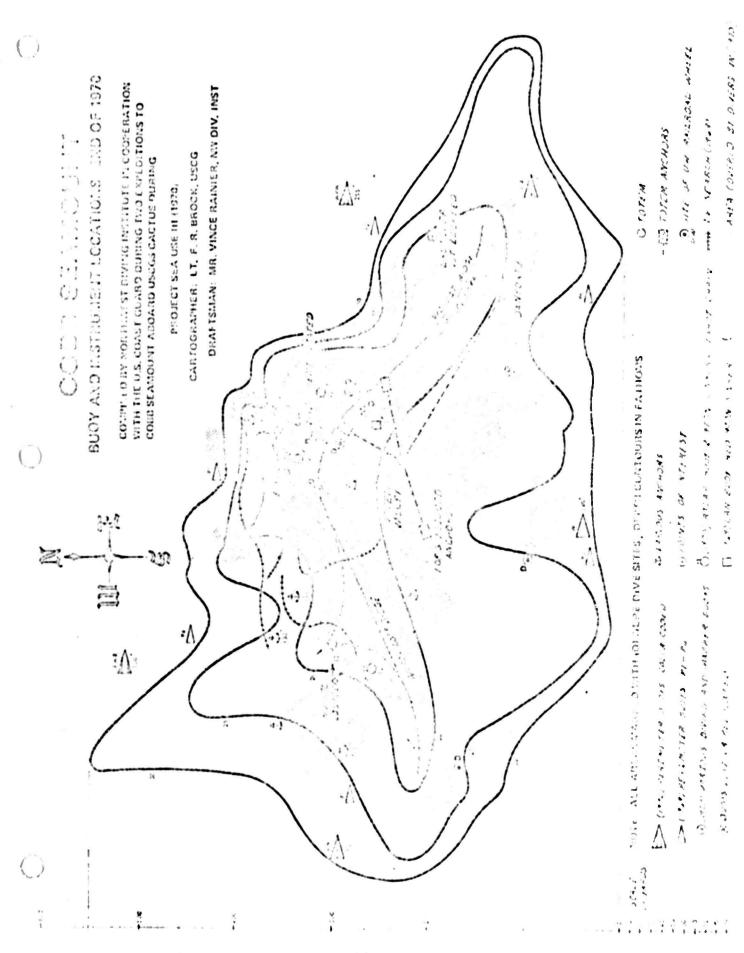
Figure 3

By daylight, 31 July 1970, the wind had shifted around to becoming a fresh breeze from the north, which moved FS-313 far enough out of position to the south that recovery of the coring drill was considered to be hazardous to the rig. After watching the fitful weather in hopes of a further wind shift until noon, a review of the bathymetry of the top of the pinnacle indicated the possibility of rigging a hawser from the ship to one of the Totem 2 clumps (see Figure 3), thus enabling

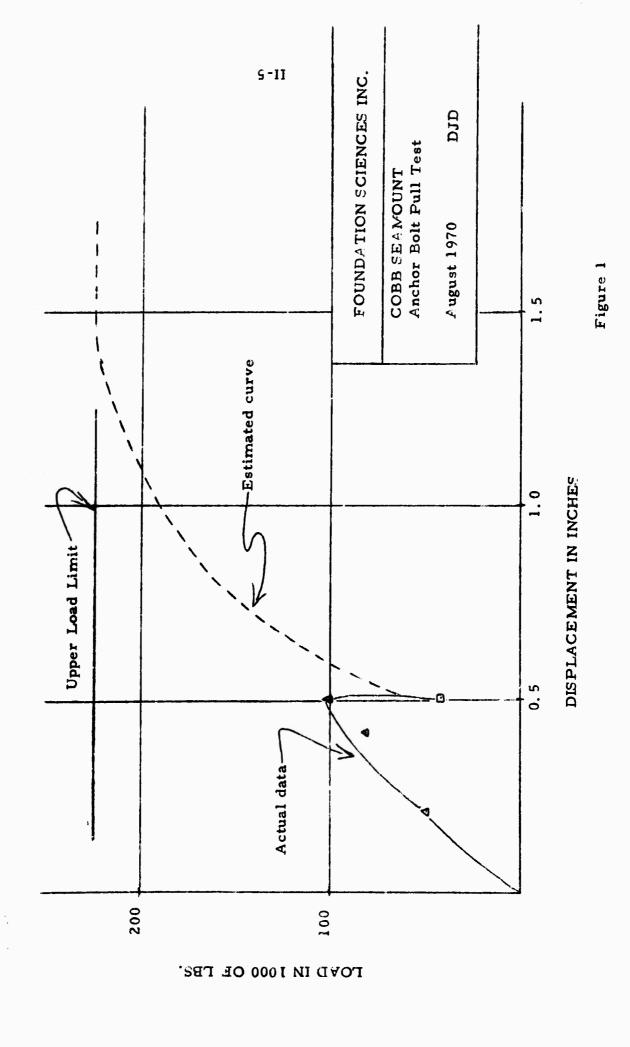
Figure 1 is a plot of the results of the rock bolt moorage pull test. The failure of the moorage was between the rock bolt and the grout.

Prior to failure, the bolt was loaded twice to loads in excess of 50 tons and each time, during diver team changes, the load dropped to 20 tons. This indicates that the non-creep load of the tested moorage is about 20 tons.

- 1. The moorage system failed along the bond between the bolt and the grout. This was primarily due to the short depth of embedment of the bolt. Future moorage systems of this type should have a minimum of 60 rod diameters of embedment in grout.
- 2. Care should be taken to assure that the bolt is free from scale and oil before it is installed in the hole.
- 3. Deeper embedment of the bolt would also increase the non-creep load capacity of the system.
- 4. The use of a resin grout in place of the cement grout should be considered as it has higher early strength and is easy to install.
- 5. The general system and method has possibilities of application to a wide variety of bottom conditions including soft bottoms.
